Feasibility Study for the Restoration of Ridinger Lake

**Ridinger Lake Homeowners Association ,
RR3, Box 295
Pierceton, Indiana 46562**

**International Science & Technology, Inc.
P.O. Box 349
10501 Hague Road
Fishers, Indiana 46038**

October 1990

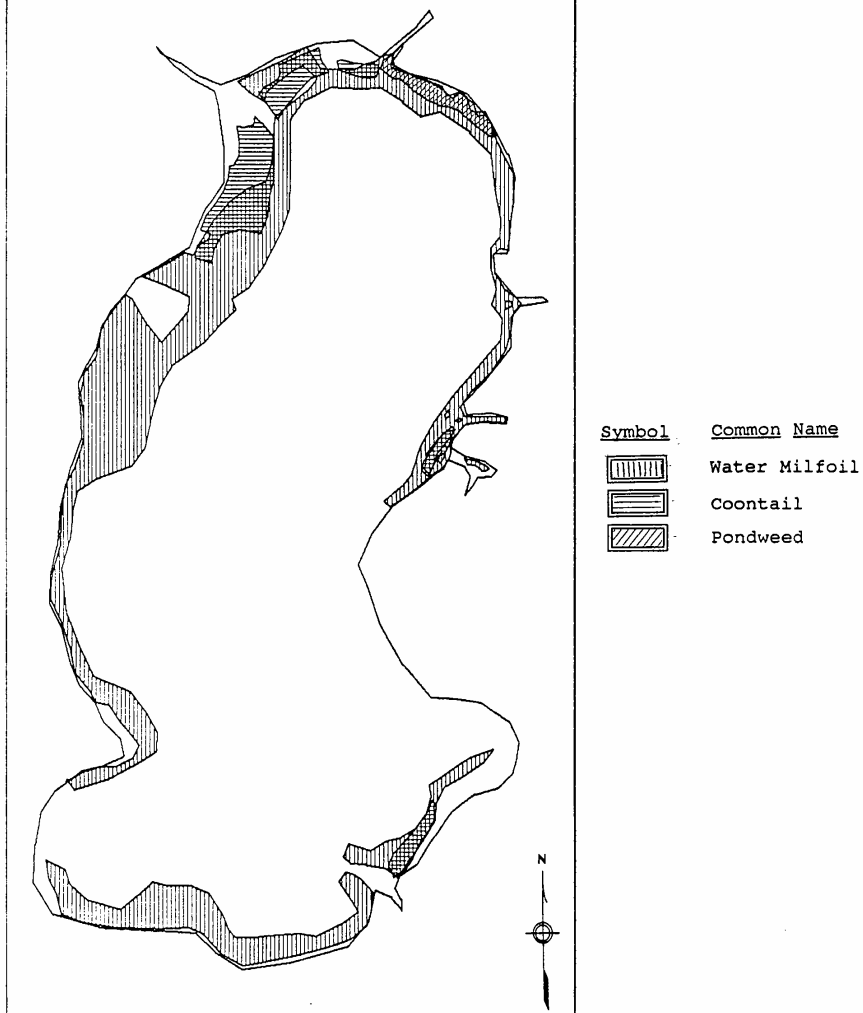
**FIGURE 7a. Ridinger Lake aquatic plant survey: submergent species.
(26-27 September 1989)**

The aquatic plant survey of Ridinger Lake documented 14 species of aquatic macrophytes (Figures 7a, 7b & 7c and Table 17). The predominant species included water milfoil (Myriophyllum spicatum), a submergent, and two species of floating-leafed water lilies; yellow water lily (Nuphar advena) and white

water lily (Nymphaea odorata). Water milfoil was present in the shallower waters along the entire lakeshore, with the exception of a small portion of the southeast and southwest shores. The milfoil beds extended up to 70 feet into the lake along portions of the west shore. Yellow water lily was observed growing predominantly in the shallow waters near the lake outlet, and along the southeast shore near the Elder Ditch inlet. White water lily was also present near the lake outlet, and observed along the west shore.

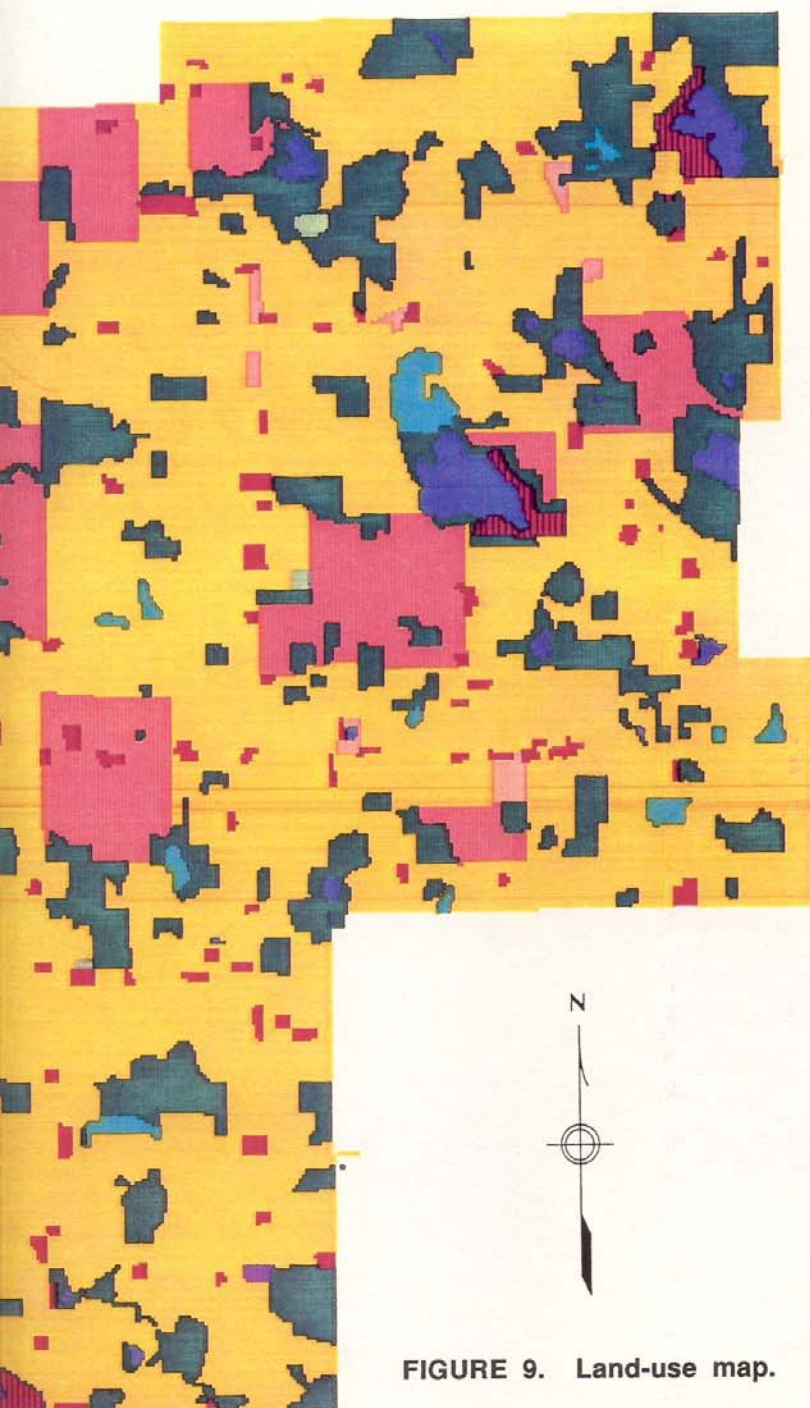
FIGURE 9. Land-use map.

The primary land use within the Ridinger Lake watershed was row crop agriculture, accounting for 57.7% of the total area. Blocks of row crops were found uniformly dispersed throughout the entire basin. Forested land constituted 19.1% of the watershed area and was found throughout the drainage basin, with higher densities located along the Elder Ditch corridor. Non-row crop agriculture comprised the third highest percentage of land use (11.8%), and was also found throughout the watershed. Row crop and non-row crop agriculture together comprised 69.5% of the watershed area and, as such, presented the most significant potential source of sediment and nutrient loading to Ridinger Lake.

The three residential use categories together accounted for only 4.3% of the watershed area, with larger concentrations occurring in the town of Pierceton and along the west shore of the lake. The immediate shoreline of Ridinger Lake is characterized by forested land with medium density residential areas located along the west and east shores and the Elder Ditch inflow.
